# Vehicle Impact Bollards No Longer Required for Cylinder Storage and Exchange Cabinets

NPGA Research Project Leads to Change in International Fire Code

By Jeffrey M. Shapiro, P.E., FSFPE  
President, International Code Consultants

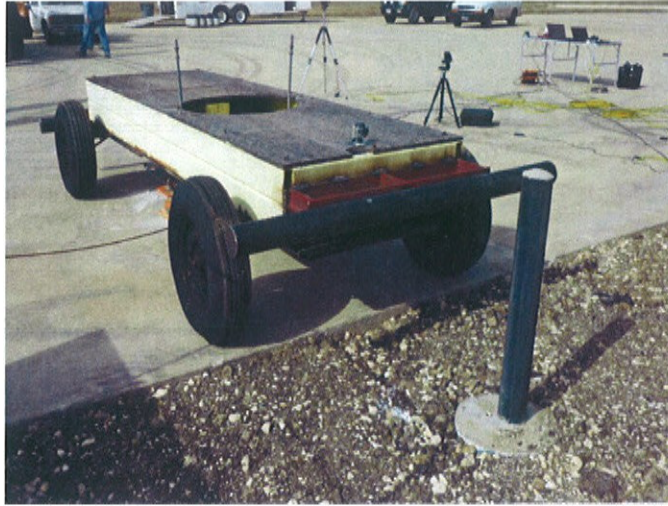
*Figure 4 URB-1 Bollard Prior to Testing*

Test ID	TEST RESULTS			
	CONFIGURATION	IMPACTOR	ACTUAL IMPACT SPEED (mph)	DAMAGE/COMMENTS
URB-1	Unrestrained Bollard	6,000-lb Bogie	15.9	Bollard deflected nearly horizontal; bogie vehicle NOT stopped
URB-2	Unrestrained Bollard	6,000-lb Bogie	6.0	Bollard deflected approximately 45°; bogie vehicle stopped
URB-3	Unrestrained Bollard	4,000-lb Bogie	4.7	Bollard pushed back and deflected approximately 15°; bogie vehicle stopped
URB-4	Unrestrained Bollard	4,000-lb Bogie	9.8	Bollard deflected approximately 45°; bogie vehicle stopped on bollard
RB-1	Restrained Bollard	6,000-lb Bogie	11.5	Bollard sheared at base; bogie vehicle NOT stopped
RB-2	Restrained Bollard	6,000-lb Bogie	5.4	Bollard deflected approximately 15°; bogie vehicle stopped
RB-3	Restrained Bollard	4,000-lb Bogie	4.5	Minimal bollard deflection; bogie vehicle stopped
RB-4	Restrained Bollard	4,000-lb Bogie	10.1	Bollard sheared at base; bogie vehicle NOT stopped

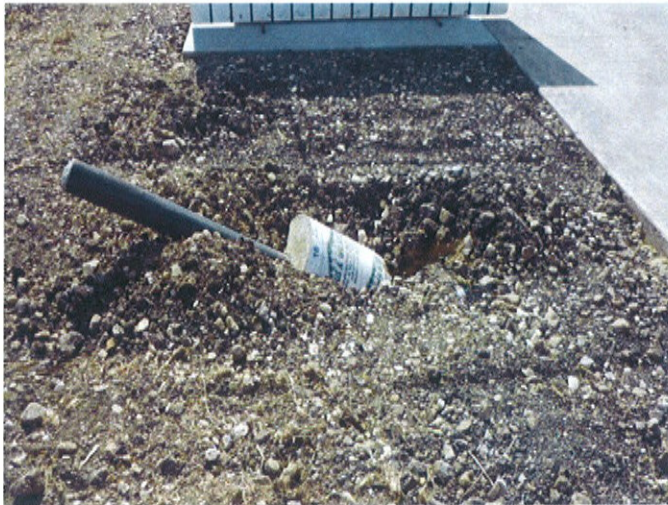
*Figure 5 URB-1 Bollard Following Testing*

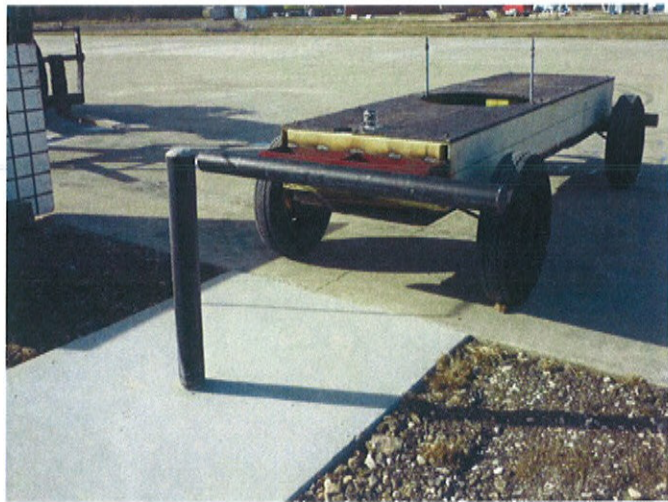
*Figure 6 RB-2 Bollard Prior to Testing*

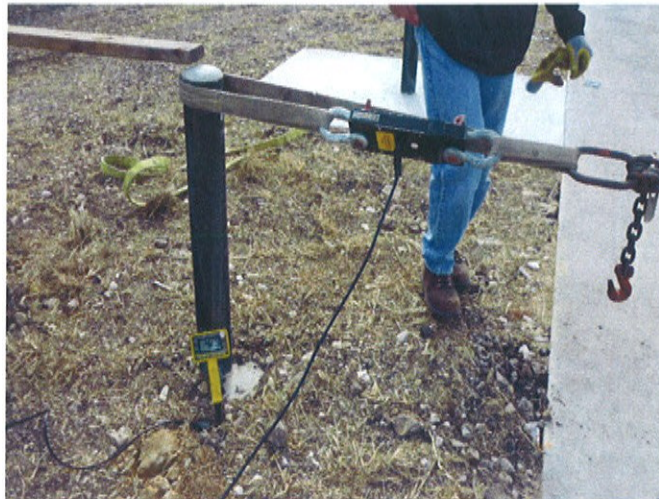
*Figure 8 URBS Bollard Prior to Testing*

URBS	Unrestrained Bollard	N/A – Static Test	N/A	Approximately 900 lbs. maximum load; permanent deflection less than 1 inch
RBS	Restrained Bollard	N/A – Static Test	N/A	Approximately 11,000 lbs. maximum load; 3 inches permanent deflection

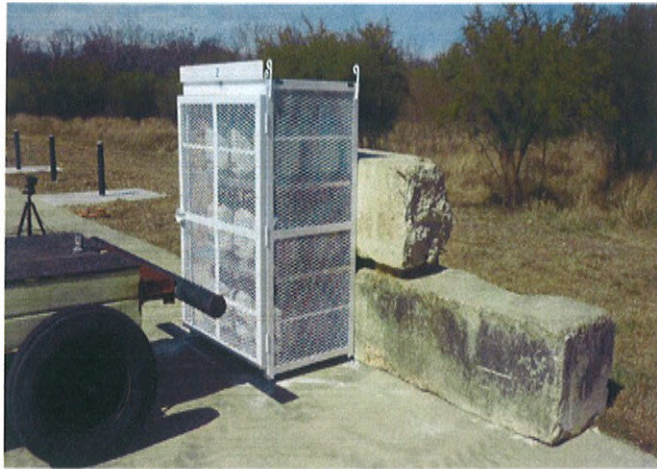
*Figure 9 SC-1 Cabinet Prior to Testing*

Test ID	TEST RESULTS			
	CONFIGURATION	IMPACTOR	ACTUAL IMPACT SPEED (mph)	DAMAGE/COMMENTS
SC-1	Steel Cabinet, Anchored, Backstop	6,000-lb Bogie	8.6	Majority of damage to center shelf; no damaged cylinders; bogie vehicle stopped
SC-2	Steel Cabinet, Anchored	6,000-lb Bogie	8.7	Front mounting tabs torn; cabinet knocked over; no damaged cylinders; bogie vehicle stopped
SC-3	Steel Cabinet, Anchored, Backstop	4,000-lb Bogie	8.5	Majority of damage to bottom shelf; no damaged cylinders; bogie vehicle stopped
SC-4	Steel Cabinet, Anchored, Backstop, Overloaded Shelves	4,000-lb Bogie	10.0	Loaded with 20 cylinders; majority of damage to bottom shelf; no damaged cylinders; bogie vehicle stopped
SC-5	Steel Cabinet, Anchored	4,000-lb Bogie	10.1	Front mounting tabs torn; cabinet pushed back; no damaged cylinders; bogie vehicle stopped
AC-1	Aluminum Cabinet, Backstop	6,000-lb Bogie	8.9	Significant crushing of center shelf; two damage cylinders; bogie vehicle stopped

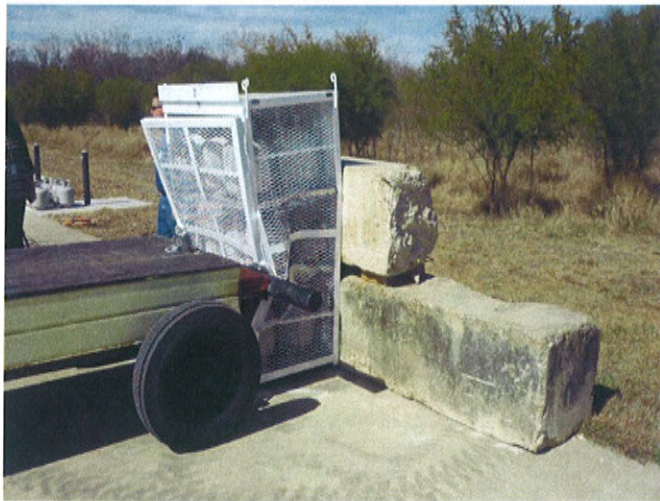
*Figure 10 SC-1 Cabinet Following Testing*

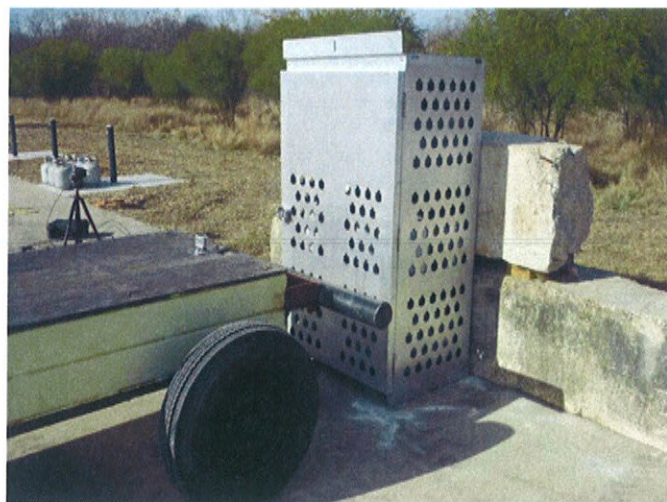
*Figure 11 AC-1 Cabinet Prior to Testing*

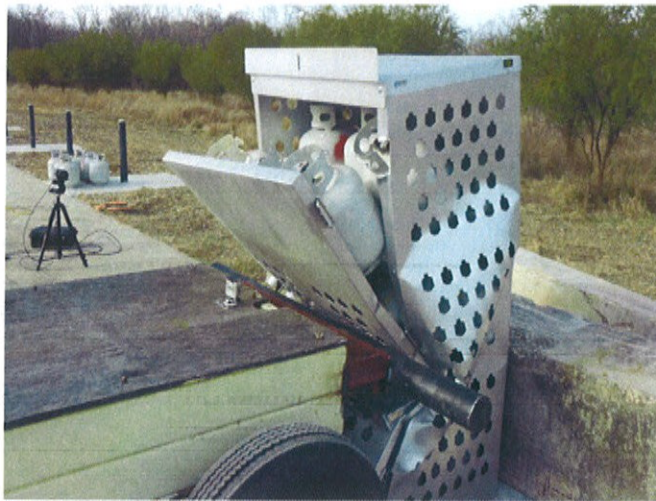
*Figure 12 AC-1 Cabinet Following Testing*

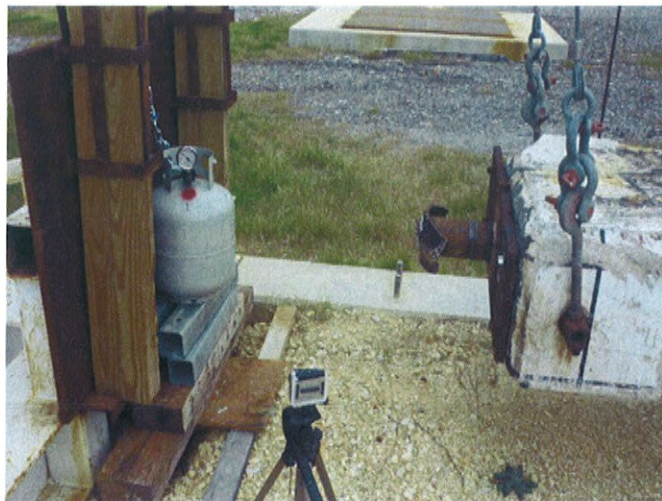
*Figure 13 CYL-1 Cylinder Prior to Testing*

Test ID	TEST RESULTS			
	CONFIGURATION	IMPACTOR	ACTUAL IMPACT SPEED (mph)	DAMAGE/COMMENTS
CYL-1	Center Impact (At Seam)	4,000-lb Pendulum	2.7	Baseline duplicate damage; no rupture or leak; PRV not activated
CYL-2	High Impact (Above Seam)	4,000-lb Pendulum	2.7	Baseline duplicate damage; no rupture or leak; PRV not activated
CYL-3	Center Impact (At Seam)	4,000-lb Pendulum	5	No rupture or leak; PRV not activated
CYL-4	Low Impact (Below Seam)	4,000-lb Pendulum	2.7	Baseline duplicate damage; no rupture or leak; PRV not activated
CYL-5	High Impact (Above Seam)	4,000-lb Pendulum	5	No rupture or leak; PRV not activated
CYL-6	Low Impact (Below Seam)	4,000-lb Pendulum	5	No rupture or leak; PRV not activated
CYL-7	Center Impact (At Seam)	4,000-lb Pendulum	10	Cylinder ruptured; activation of PRV
CYL-8	Low Impact (Below Seam)	4,000-lb Pendulum	10	No rupture or leak; activation of PRV
CYL-9	High Impact (Above Seam)	4,000-lb Pendulum	10	Cylinder ruptured; activation of PRV

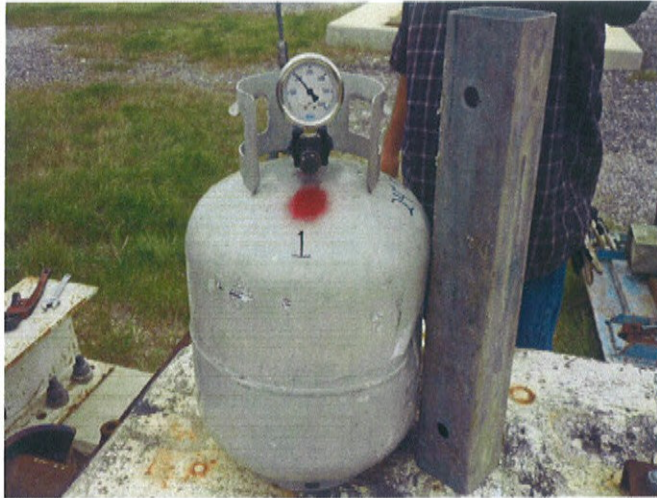
*Figure 14 CYL-1 Cylinder Following Testing*

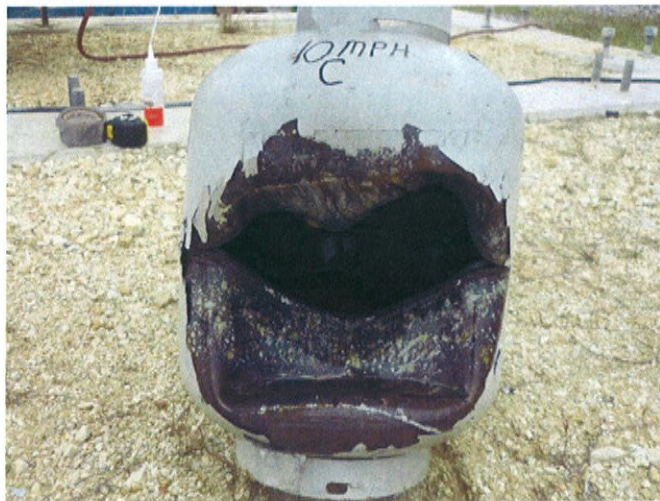
*Figure 15 CYL-7 Cylinder Following Testing*
